5 January 2016

RE: Field Activity Report
San Jacinto River Waste Pits
Remedial Investigation/Feasibility Study Oversight
Channelview, Harris County, Texas
Contract: EP-W-06-004
Task Order: 0130-RSBD-06ZQ

**FIELD ACTIVITY REPORT
23 AND 28–31 DECEMBER 2015
SAN JACINTO RIVER WASTE PITS
CHANNELVIEW, HARRIS COUNTY, TEXAS**

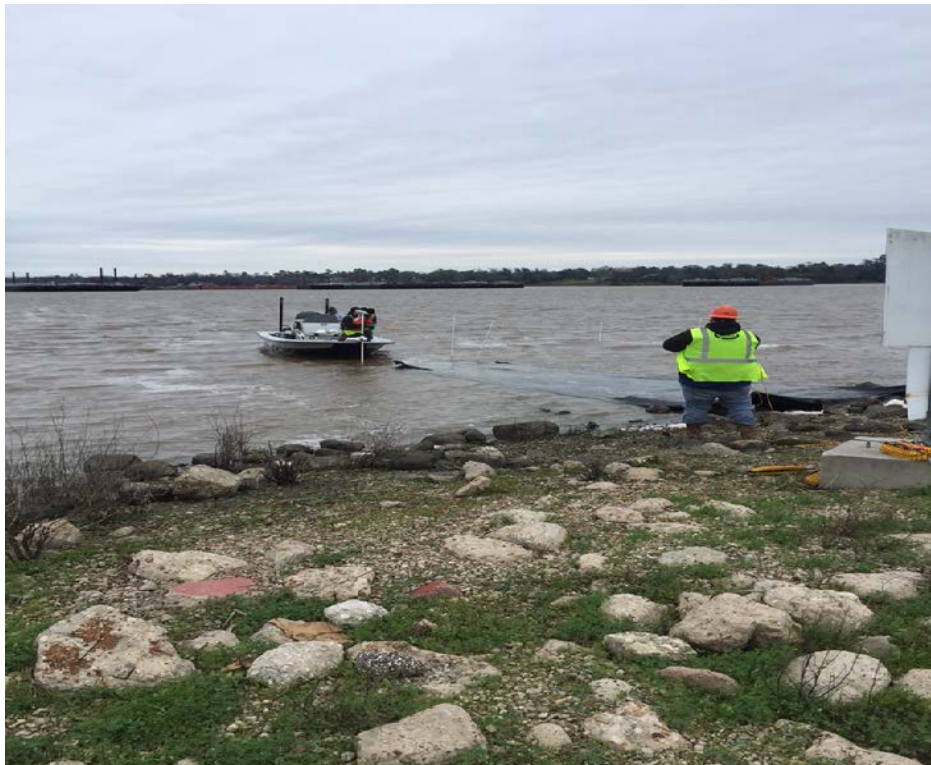
- USA Environmental experienced difficulty in getting the fabric from the shore to the WA. Several attempts were needed to get the proper boat orientation. The rip rap used to “pin” the north east corner of the fabric was dropped from approximately 10 feet, exceeding the work plan height of 2–3 feet.

30 December 2015: Attempting to place fabric in the area of concern.

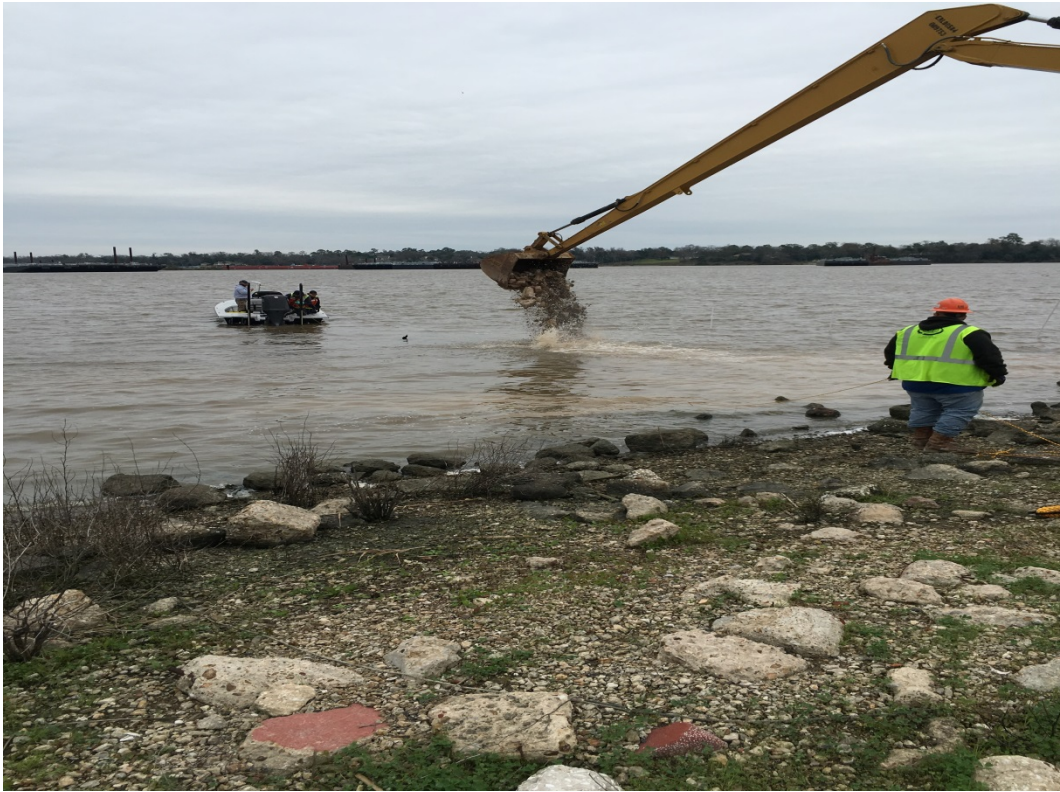
30 December 2015: USA Environmental dumping rip rap from over 3 feet.

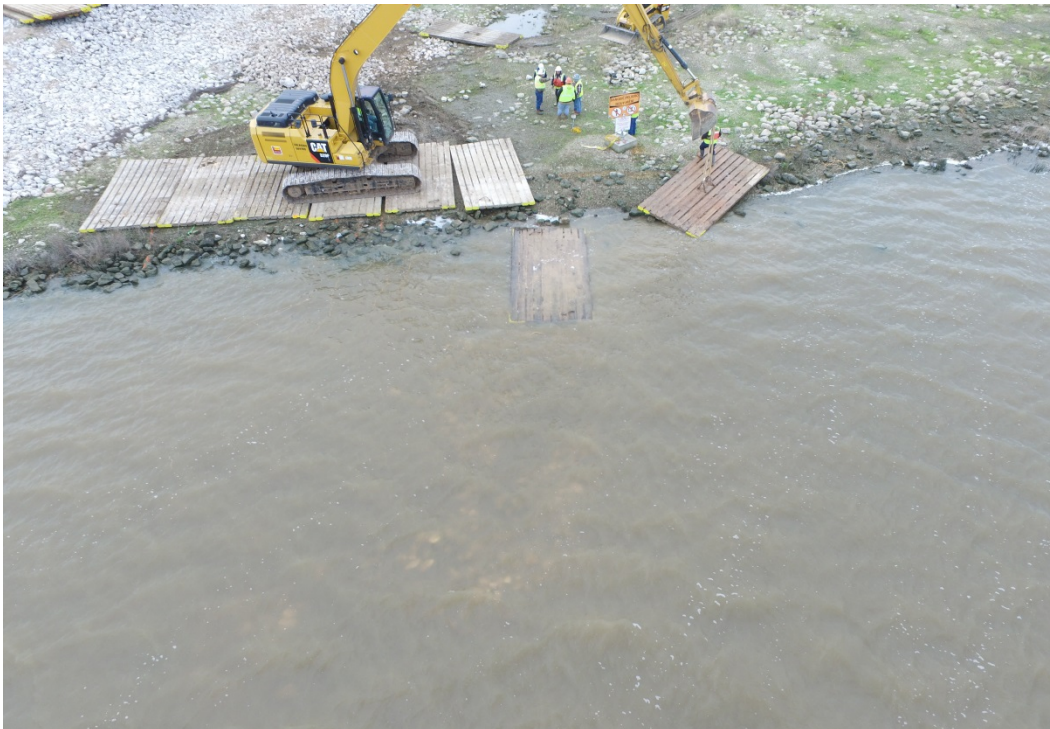
31 December 2015: USA Environmental staging crane mats for probing activities.

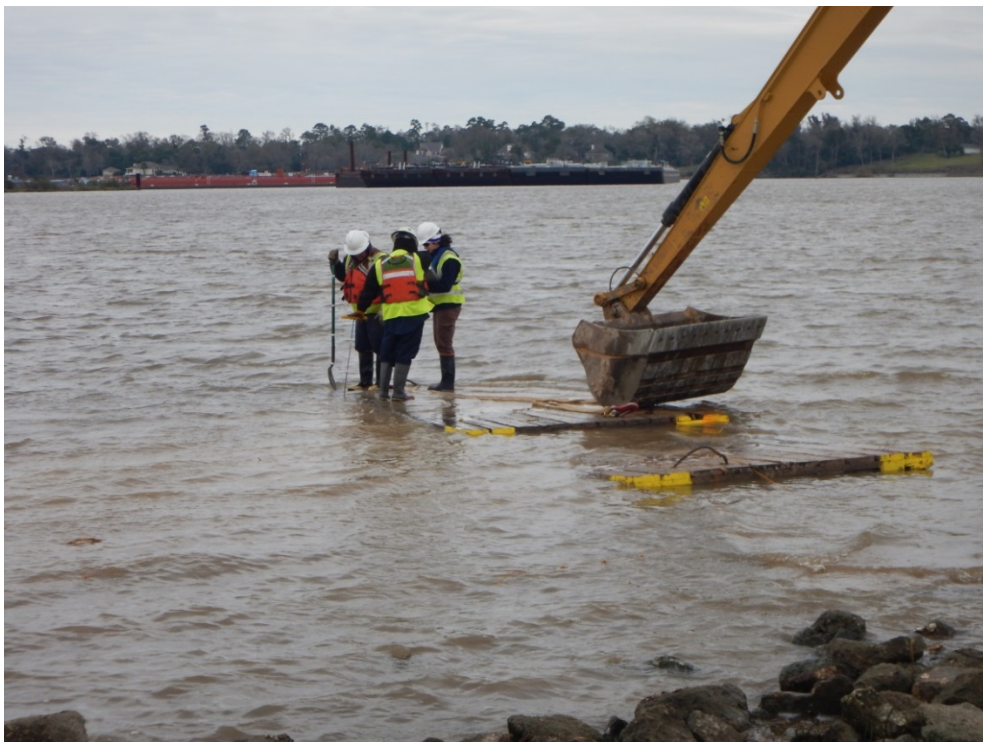
31 December 2015: Anchor and USA Environmental probing rip rap thickness.

- At 0942 hours additional rip rap was placed at the western edge of the WA after probing measurements came up at a thickness of 9 inches.
- From 0942 hours until 1054 hours Anchor and USA Environmental continued probing, moving first east then north to cover the WA. Anchor and USA Environmental reported that the top of the rock was visible from the crane mats. EA attempted to use aerial photography to confirm the extent of the rip rap repair. The turbidity and roughness of the water prevented definitive images from the air above the cap. Photographic documentation obtained during the field activities are provided at the end of this report in Appendix A. Scanned pages of the field logbook are included in Appendix B.
